# Evaluation of Failure in Low-k Films Using Stiffness Mapping and Dynamic Imaging

## Application Note

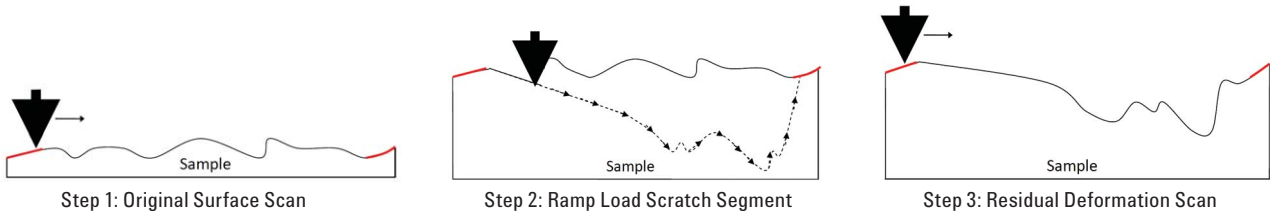
Figure 1. Diagram of the three-step ramp load scratch test. Red lines show the areas of pre and post profile scans used to perform leveling of the 3 steps.

Ramp-load scratch testing was also conducted using a cube-corner tip. In a ramp-load scratch test, the tip is brought into contact with the sample; then, the tip is loaded at a constant loading rate while simultaneously translating the sample. Prior to and following the scratch test, a single-line-scan of the surface topography is completed for comparing the original surface to the deformation caused by the scratch test. Therefore, each scratch test consists of three steps: a single-line pre-scan of the area to be scratched, the ramp load scratch test, and a final scan to evaluate the residual deformation. Before and after each step, a pre-scan and a post-scan, usually equal to 10% or 20% of the scratch length, is performed so that the software can automatically align the data in the three steps. The original and residual single-line scans allow for the

evaluation of deformation mechanisms and the quantification of deformation. The scratch process is diagramed in Figure 1.

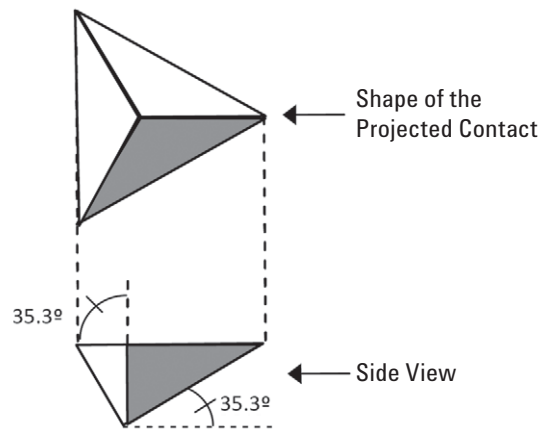
Figure 2. Diagram of cube corner tip.

The tip chosen for conducting the scratch tests was a cube-corner tip with a tip radius that was, nominally, less than 50 nm. A cube-corner tip creates a triangular projected contact with the sample; this tip geometry creates high levels of stress in the material during the scratch. Scratches can be performed either face-forward or edge-forward when using a pyramid shaped indenter. Scratching face-forward with the cube-corner tip acts like a snow plow and pushes the material out of the way, while edge-forward cuts the material

like a knife. A diagram of a cube-corner tip is shown in Figure 2. The low-k samples were tested using the cube-corner tip positioned so that it scratched face-forward.

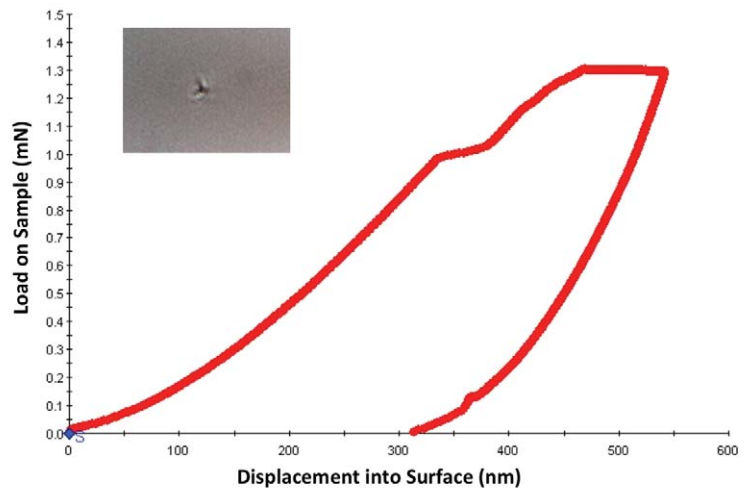
Figure 3. Load displacement curve of an indentation performed on the low-k film to introduce cracking. The residual impression is displayed in the upper-left (1000X magnification).

Fractures were created in the low-k film using a cube-corner indentation tip and performing a quasi-static indentation test up to 1.3 mN of force. Fracture of the film can be seen in the load versus displacement curve shown in Figure 3 when the load reached a value of 0.99 mN. These cracks continued to propagate as the sample was loaded to 1.3 mN—small signs of continued fracture were apparent at forces of 1.16 mN and 1.26 mN. The residual microscope image, at 1000X magnification, of the indentation test is shown in the upper left corner of Figure 3. While small cracks are apparent, measurements of the crack lengths would not be possible. Therefore, dynamic imaging of the residual indentation was performed to provide a means for measuring the crack lengths in the material without having to transfer the sample to another instrument, such as a scanning electron microscope, for imaging.

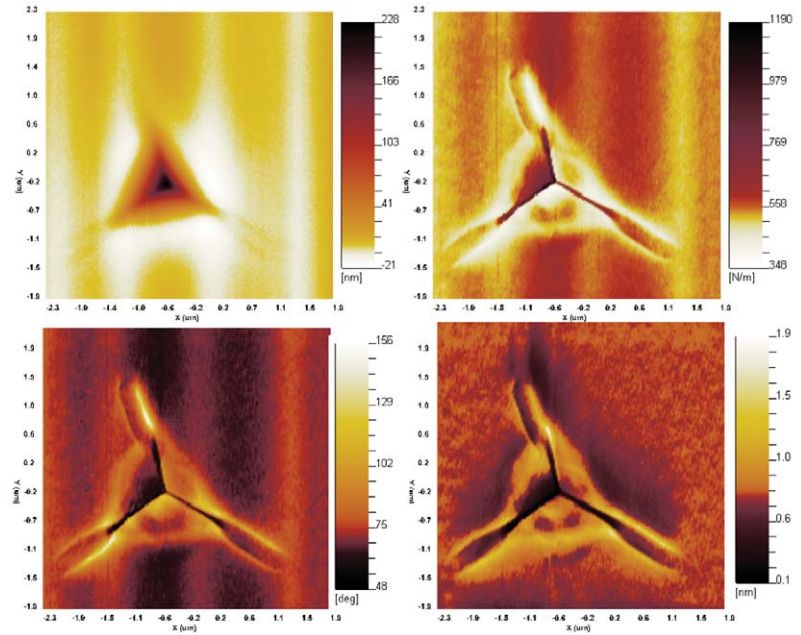
Figure 4. Topography (upper left), stiffness (upper right), phase angle (lower left), and harmonic displacement (lower right) maps of the residual impression left from the indentation test performed in Figure 3. (4.2  $\mu\text{m}$  scan)

One dynamic scan provided the necessary data to produce topography, stiffness, phase angle, and harmonic displacement maps of the residual indentation; the four maps are all shown in Figure 4. The topographical map showed evidence of fracture; however, the crack lengths were unclear due to the poor contrast between the large displacement range used in scanning the indent and the small scale displacements seen in fracture. Stiffness, on the other hand, showed much more contrast because only small stiffness changes were apparent due to topographical changes; but, when cracked or blistered material was encountered, the stiffness changed dramatically. During scanning, when the tip falls into a crack or a sharp edge impression, the contact area increases abruptly and a large stiffness is detected, while just removed from the crack or on a blistered section of the film the stiffness decreases abruptly due to the limited support of the surrounding material. Dynamic imaging takes advantage of the contrast created when abrupt changes in contact areas are detected. Figure 4 shows that the stiffness and phase angle maps provided the best contrast for measuring the crack lengths. The harmonic displacement map was not used in measuring the crack length because a short lag in harmonic displacement control was apparent after scanning the top crack.

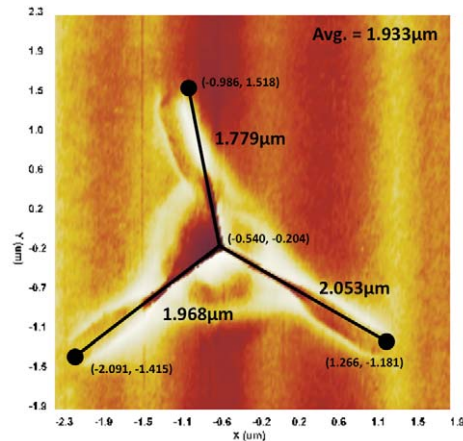
Figure 5. Crack length measurements using the stiffness map produced through dynamic imaging.

Each crack was measured using the stiffness map in Figure 5 and an average crack length of 1.933  $\mu\text{m}$  was determined. A first order approximation of the fracture toughness can be determined using the elastic modulus ( $E$ ) and hardness ( $H$ ) of the film along with the maximum load ( $P$ ) and crack length ( $c$ ) from an indentation test with a cube-corner tip using the relationship in Equation 1 [1].

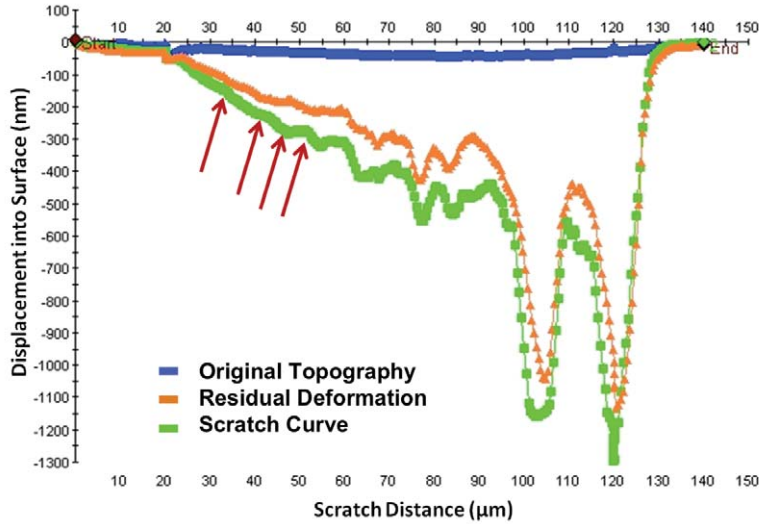
Figure 6. The scratch results (original topography, scratch cycle, and residual deformation) from a typical ramp-load scratch test on the low-k film using a maximum force of 1 mN. Arrows indicate failure in the film.

Scratch testing was conducted on the low-k film to better understand failure modes of the film and to better understand separation of the film from the substrate. A ramp-load scratch test to a maximum load of 1 mN was used to conduct 100  $\mu\text{m}$  long scratches. In examination of the resulting scratch curves, multiple points of failure were apparent—the scratch curves for a typical test are shown in Figure 6 with arrows indicating the locations of multiple failure points and possible locations of interface failure. Figure 6 also shows the scans of the original topography (blue), scratch cycle (green), and the residual scan (orange). There was a significant amount of plastic deformation observed in the scratch curves—plastic deformation is depicted by the area between the original topography and the residual deformation, while elastic deformation is depicted by the area between the residual deformation and the scratch cycle—leading up to failure. However, there was insufficient information in the data to decouple deformation mechanisms such as plastic deformation, blistering, and chipping; dynamic imaging of the failure region was used to decouple the three deformation mechanisms and correlate the results to the scratch curves.

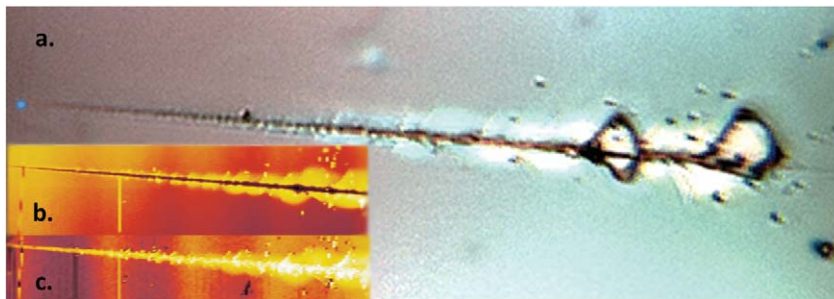
Figure 7. Microscope image (a.) of the residual scratch at 1000X magnification aligned with the topography scan (b.) and the stiffness map (c.) of the region of failure.

The topography scan and stiffness map of the failure region are shown in Figure 7 aligned with the microscope image of the residual scratch taken at 1000X magnification; this figure shows that failure of the low-k film occurs far before it can be observed in the microscope image. The topography

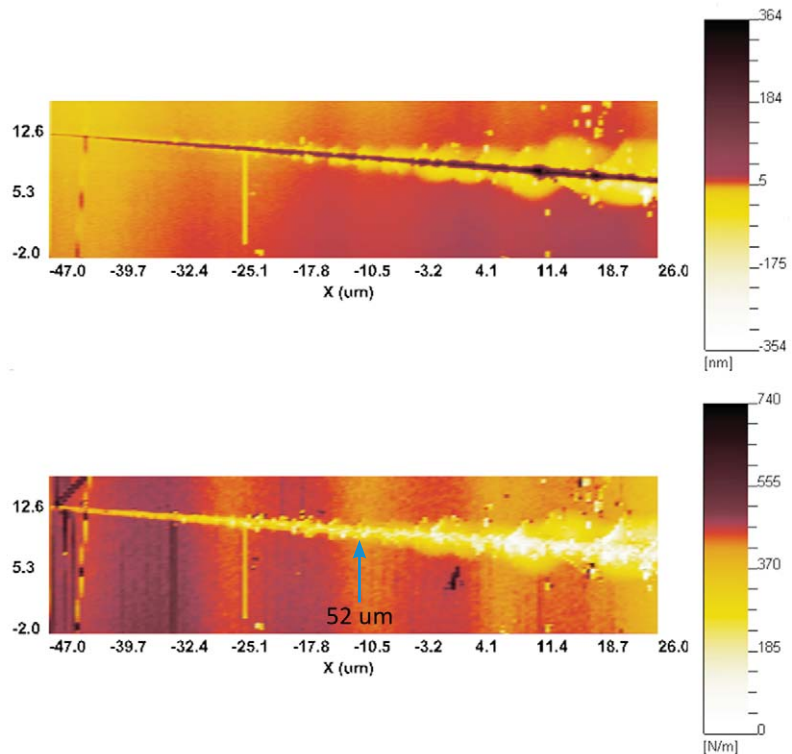
Figure 8. Topography and stiffness maps of the failure region.

and stiffness maps are shown in greater detail in Figure 8. While the topographical image shows early failure of the film, this failure is dominated by minor pile-up and possibly chipping which does not classify as interfacial failure. By examination of the stiffness map, clear blistering does not start until a scratch distance of  $52\ \mu\text{m}$  is reached; this region is indicated on the stiffness map in Figure 8. Blistering was determined from the stiffness map when the area surrounding the scratch path showed clear radial propagation of low stiffness signifying that the area has separated from other material in the system and was not well supported. The critical load, defined as the first location of delamination or blistering, was located at this point. Figure 9 shows the stiffness map aligned with the scratch data and an arrow indicating the critical load point in the 2-D scratch curves.

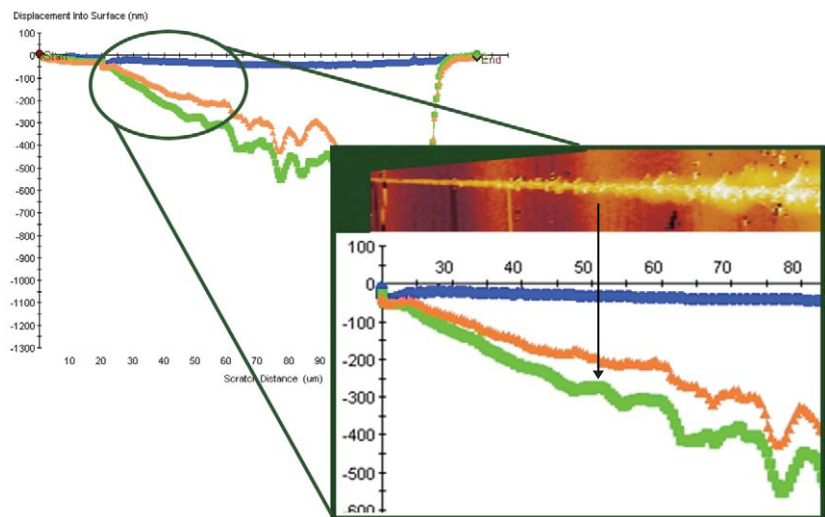
Figure 9. Scratch curves with an outset of the curves aligned with the stiffness map. The arrow locates the *finger print* of failure that indicates major failure of the film.

With the examination of the “finger prints” of failure in the scratch curves, the other scratch data on similar samples were analyzed without the need for imaging. Figure 9 shows that the scratch curve may possess dithers that represent minor chipping of the film—at scratch distances of  $35\ \mu\text{m}$  and  $42\ \mu\text{m}$  there are noticeable events that occur in the scratch curves—but an arrest of the penetration rate followed by an abrupt acceleration of penetration represented major failure of delamination or blistering in this sample. From analysis of all tests performed on this sample, failure, defined by blistering or delamination, occurred at a normal force of  $0.260 \pm 0.03\ \text{mN}$ .
